**DEVELOPMENT AND CERTIFICATION**  
**OF A RUGGED ENGINE**  
**RELATIVE TO FOREIGN OBJECT INGESTION**

**The CFM56**

**By R.J. ARIZZI  
SNECMA  
PARIS  
FRANCE**

**The Hague Oct. 1979**

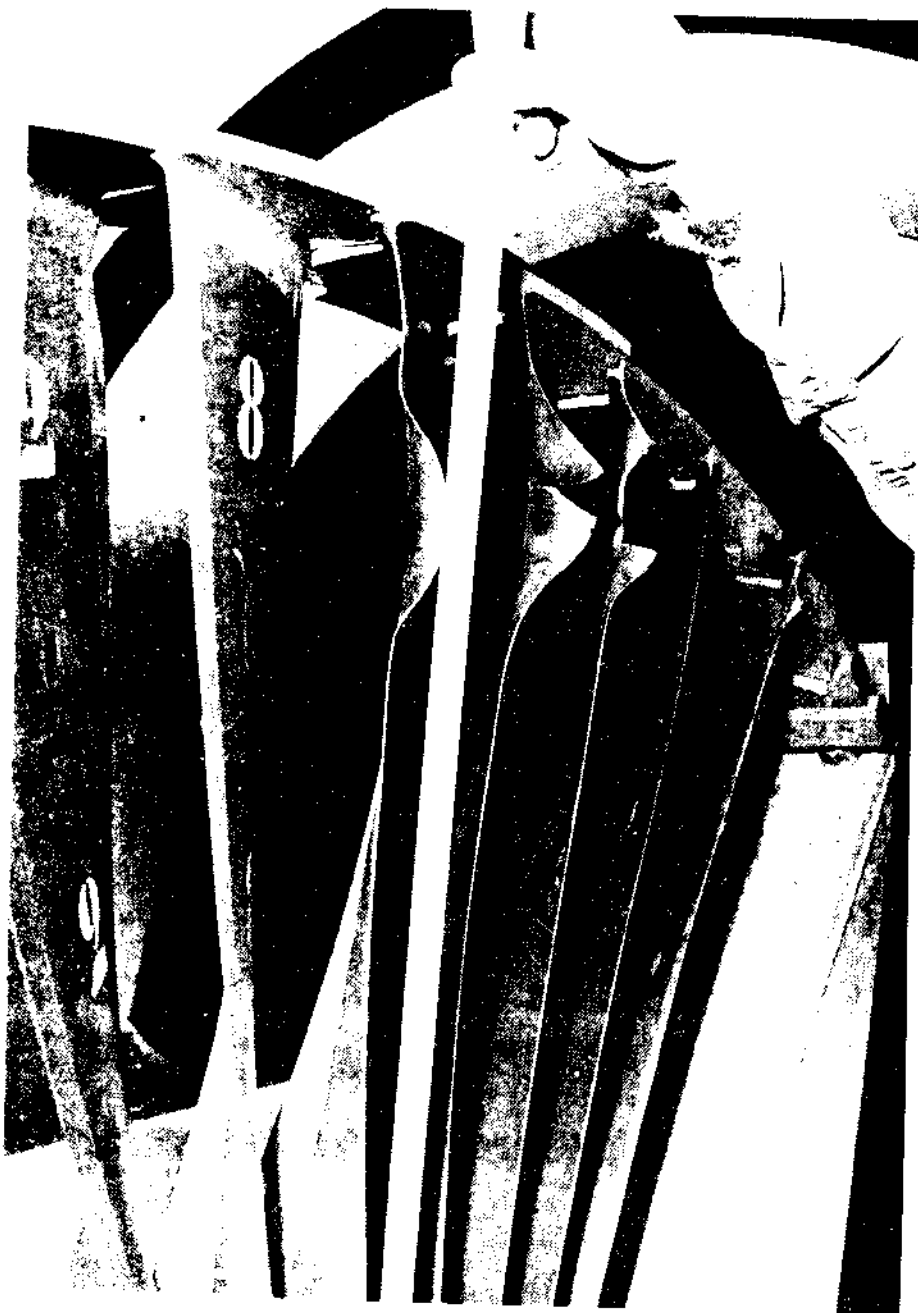
FIG. 2 - 1,5 lb bird strike on a static cascade  
- Impact par un oiseau de 1,5 lb sur secteur statique

Some fragments were generated at leading edge of blades when struck by the birds at a height of 60 % span or above.

Figures 2 and 3 show typical fragmentated blades after bird strike.

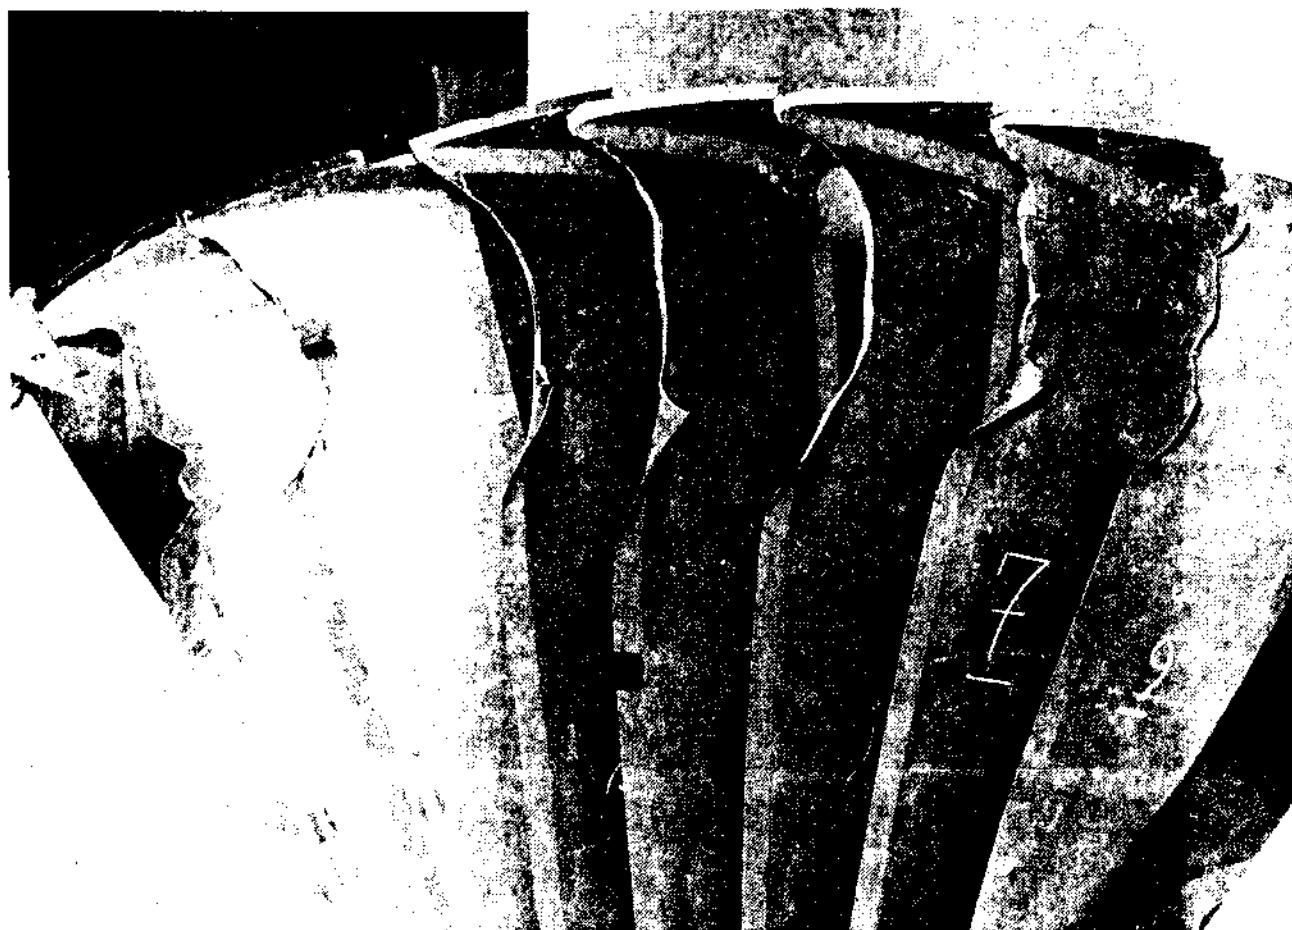
FIG. 3 - 4 lb bird strike on a static cascade  
- Impact d'un oiseau de 4 lb sur secteur statique

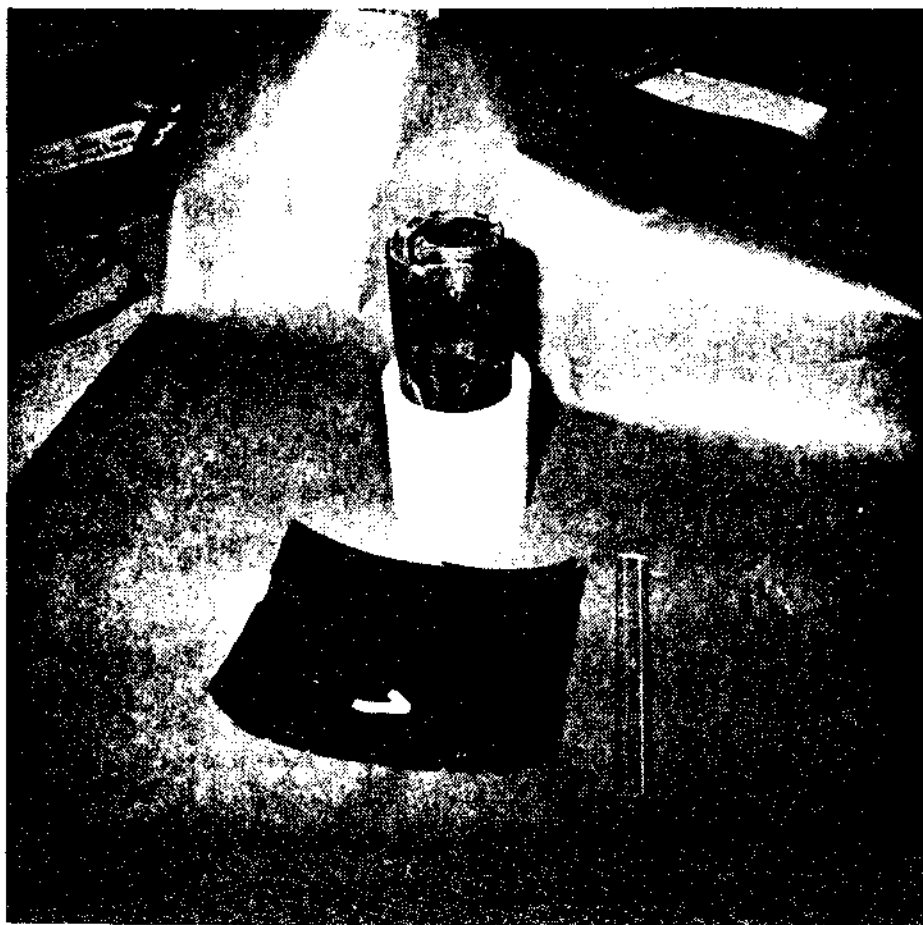
FIG. 12 - Tire tread before and after ingestion  
- Chape de pneu avant et après l'ingestion.

Fig. 12 shows one of the tire treads used for this series of tests : the piece of tire is rolled up and fitted in the plastic sabot, similar to the one used for firing the birds. A clever and simple system makes it to get deployed before hitting the rotating blades. After the test only chopped up slices are found at the bottom of the spin pit.
